Manhole Inspection Summary

Manhole # S51K__050MH

Insp Date: **3/31/08 12:32 PM**

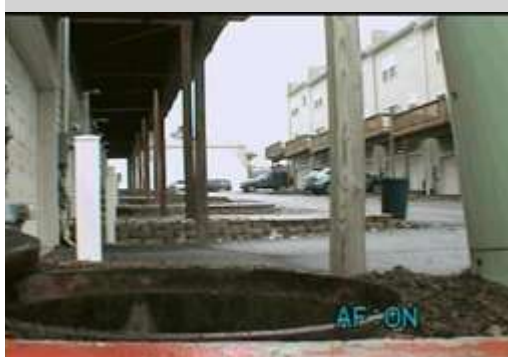
Location View

frame 1" above grade

misc. bench debris

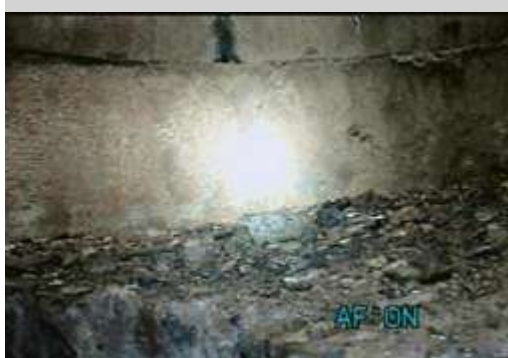
bench debris

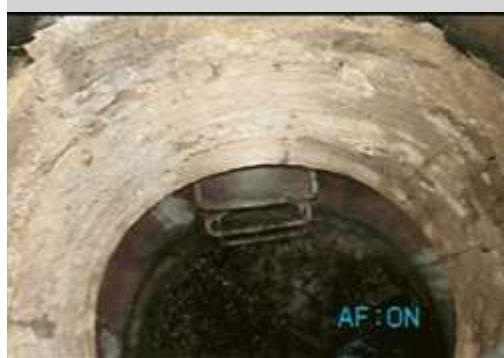
Defect 1

debris, corroded steps

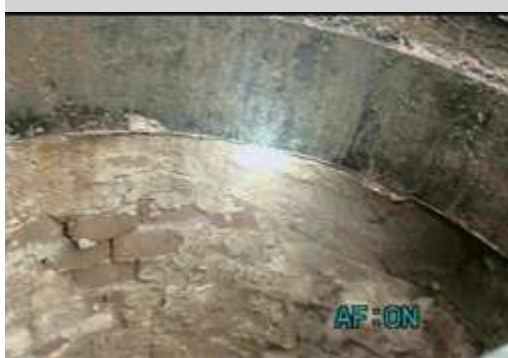
Defect 2

loose brick on frame adjustment
